Surface Rupture Damage Effect on the Active Palu-Koro Fault in Palu City, Indonesia

Abstract

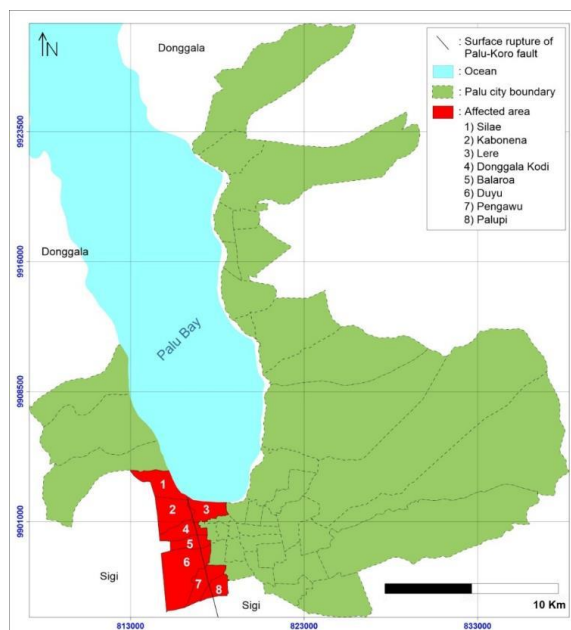
Figure 2 Sub-districts affected by the surface rupture of the Palu-Koro fault in Palu City

Many other phenomena have caused disasters, including the Mw 7.5 earthquake in 2018, such as tsunamis, landslides, and liquefaction [4], [5], [14]. It was preceded by a sinistral movement from the Palu-Koro fault. However, without these follow-up phenomena, the Palu-Koro fault would have become a hazard that caused the disaster itself through cracks traces on the surface. Palu City is the area that experienced the greatest displacement; the slip size ranges from 4.5 – 5 m [2], [4], [5]. The surface rupture length of Palu-Koro fault in Palu City is ± 6 km [6], which has an impact on 7 sub-districts namely Silae, Kabonena, Lere, Donggala Kodi, Balaroa, Duyu, Pengwu, Palupi (see Figure 2).

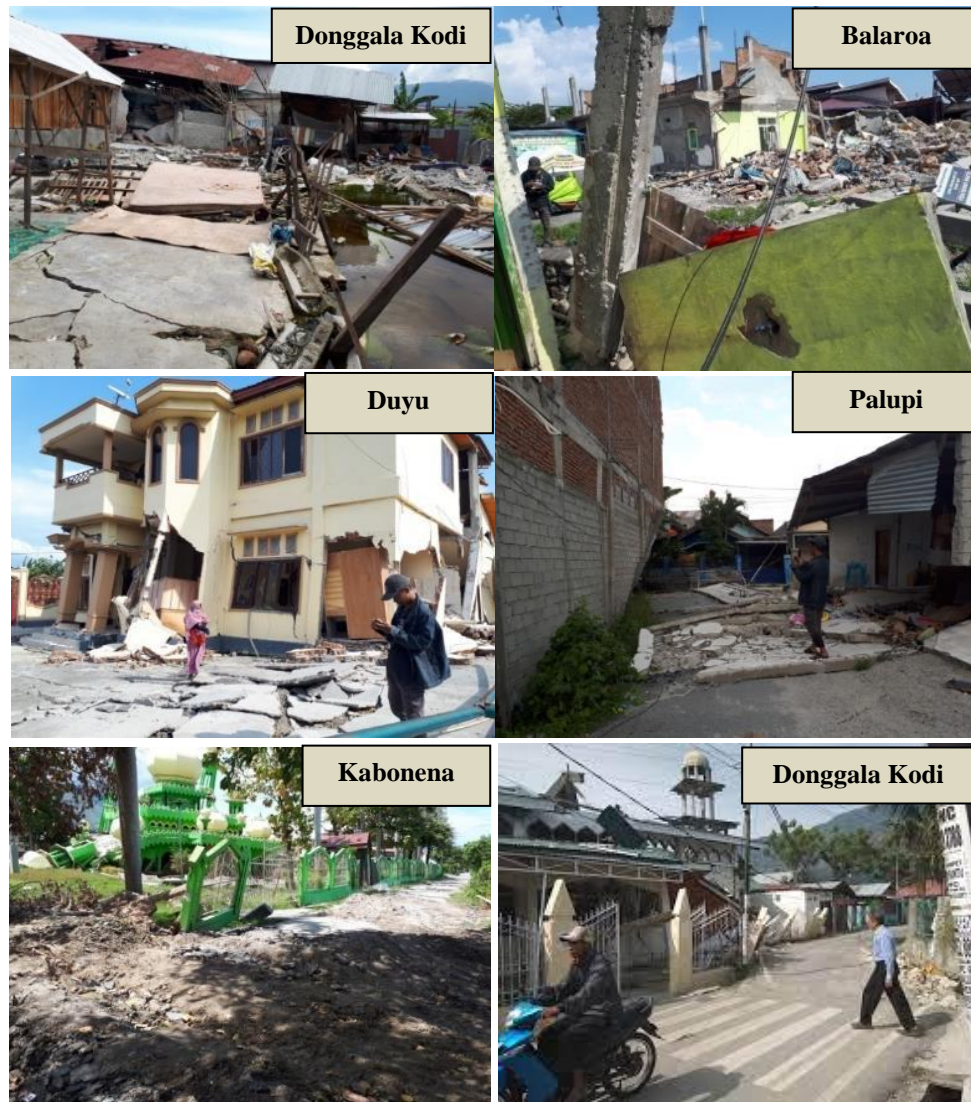
Surface rupture in Palu City is characterized by a displacement in the eastern block relative to the north and the western block relatively to the south. As a result of this displacement, many buildings, such as mosques, shops, and residents' houses, were damaged. The cracks are right under the building, causing the foundation and pillars to move from their position following the fault movement direction so that buildings that are not sturdy will collapse, and some sturdy buildings will still stand in a damaged or unstable condition (see Figure 3). It can be ascertained that this was not caused by earthquake shocks but due to the surface rupture of the Palu-Koro fault. The buildings on the east and west sides that are not around the fault line effect are relatively undamaged.

Figure 3 Buildings damaged by surface rupture, which are exactly located on the active Palu-Koro fault line

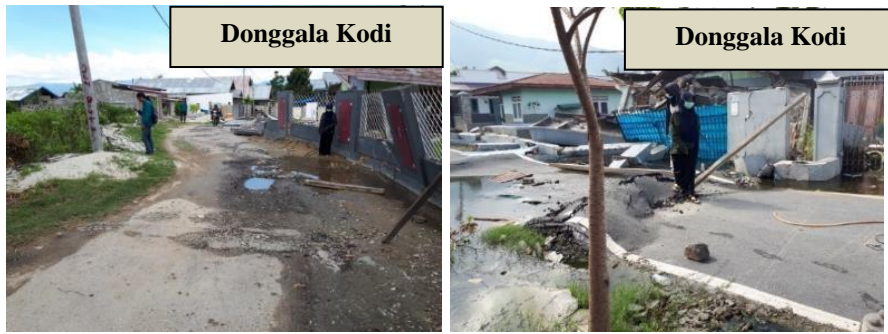
Another damaging impact is that the roads turn to follow the direction of the fault displacement, which becomes the fault plane. Some of the road asphalt conditions were observed sloped upwards, it was assessed as a result of the friction forces buildup (Figure 4).

Figure 4 The road has meanders, and the road asphalt slopes upwards due to the buildup of frictional forces from displacement faults

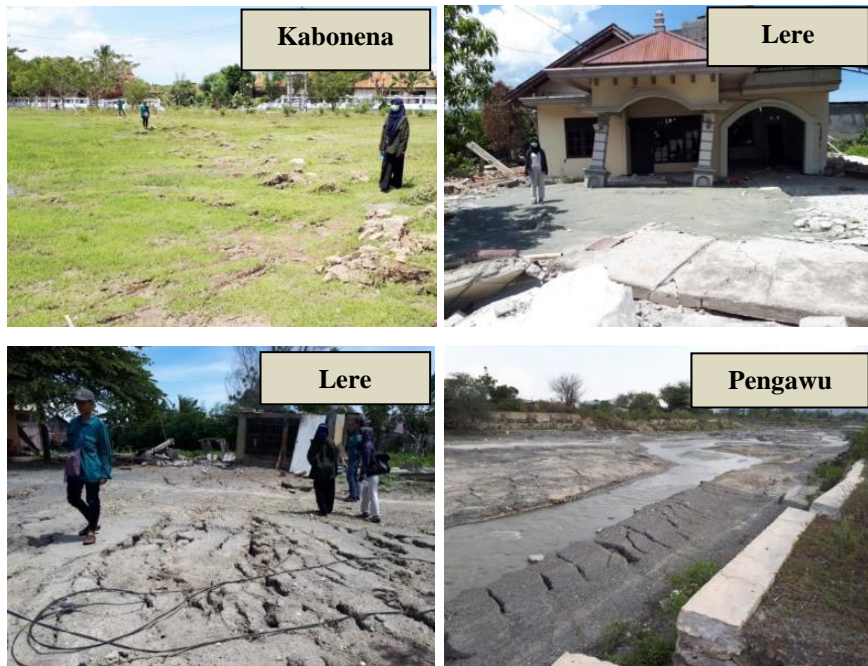
In several locations it also causes changes in surface shape, the soil seems to undulate, liquefaction effects such as sand boils and many dense cracks (Figure 5). There is also stagnant water which suspected that the water originates from shallow

Figure 5 Appearance of land shape changes around the fault boundary. The soil looks undulating, there are signs of liquefaction such as sand boils and quite dense cracks

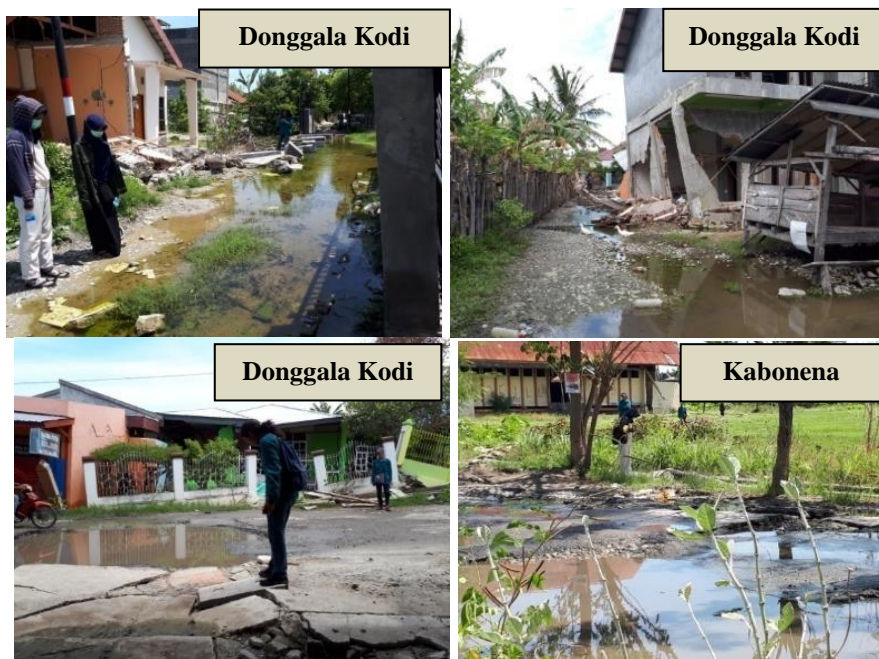
groundwater pushed out through the cracks then rise to the surface (Figure 6). The Palu City residents cannot build permanent buildings, to be used as homes or offices in the active fault zone. Because at any moment, destructive displacement is likely to recur. However, the Palu-Koro fault is considered an active fault, because it is proven that there is a left lateral strike-slip displacement every year at a rate of 34-38 mm/year [15], [16], and can produce large displacements such as the one that caused the Mw 7.5 earthquake in 2018.

Figure 6 Puddles that are thought to have originated from the subsurface at several locations along the fault line

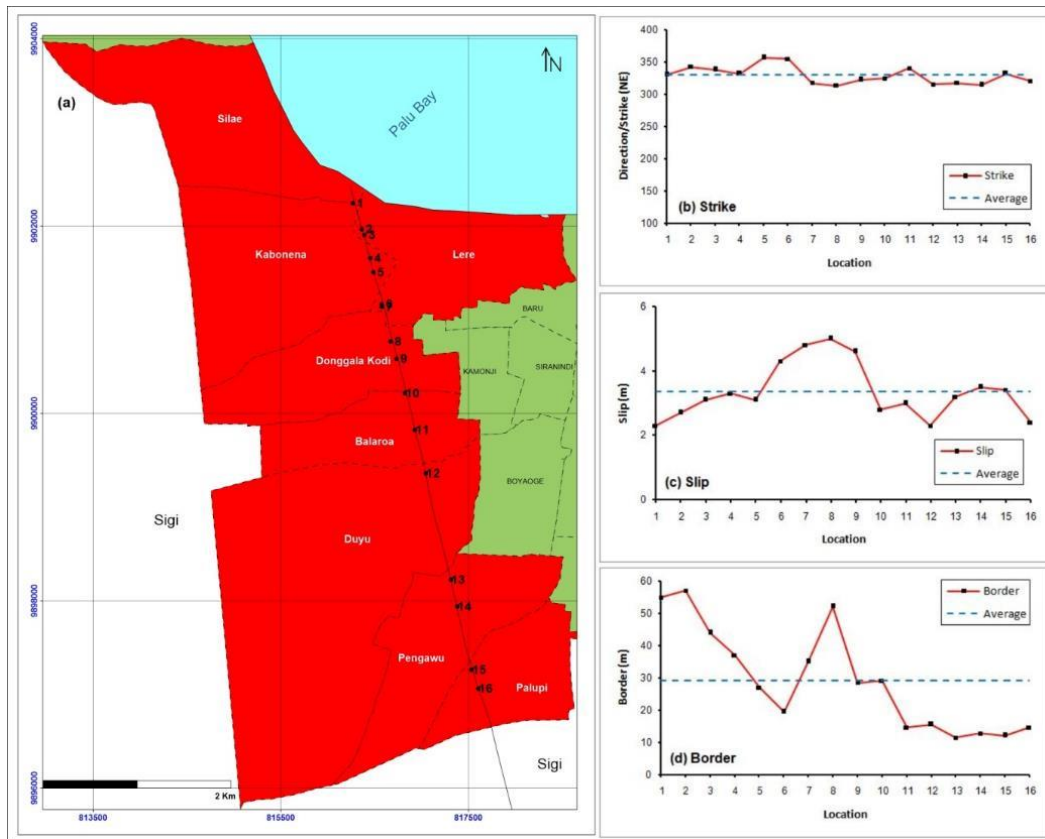
After identifying the impact, the dimensions of the damage effect zone around the fault line are measured for 16 possible locations to obtain data on strike, slip, and the width of the fault impact. The fault strike direction is mainly oriented north to northwest between N314oE and N357oE. Then the displacement data is the slip range from 2.3 – 5 m. The most significant displacements are in the central part, Kabonena, Lere, and Donggala Kodi Villages. While the fault boundaries in the northern and central regions are quite broad, the damage is 32 - 56 m, while in the south, it ranges from 11 - 16 m. Thus, the surface rupture damage effect on active faults in Palu City ranges from 11 to 56 m, perpendicular to the fault line or to the west and east sides (see Table 1 and Figure 7).

Figure 7 a) Location map of fault dimension measurement on the Palu-Koro fault line in Palu City, b) Strike data graph, c) Slip data graph, d) Fault boundary data graph
