# Determination of Slope Safety Factor Based on Hoek & Brown Collapse Criteria on Ampera-Surumana Road Section

Agung Nugraha<sup>a,1,\*</sup>, Irianto Uno<sup>a,2</sup>, Asrafil Asrafil<sup>a,3</sup>

<sup>a</sup> Engineering Faculty, Tadulako University, Indonesia,

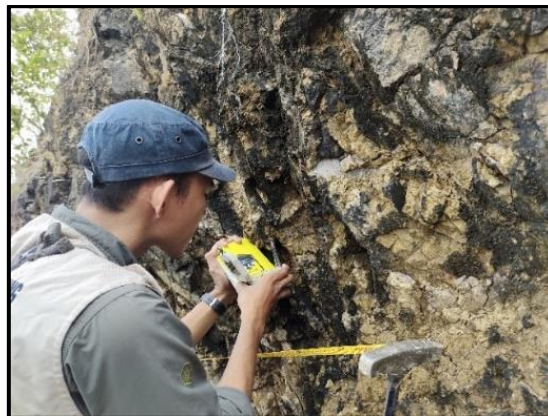
Fig. 4. The appearance of exogenic processes, namely weathering on andesite lithology at observation station 1.

The weathering process that occurs in the study area is physical weathering which is the disintegration of rocks into small fragments. The results of physical weathering are found in andesite lithology in the form of loose fragments formed due to the process of geological structures at work. Landforms in the study area are found mass movements as one of the exogenic processes that play a role in controlling the formation of morphology in the study area.

This movement is controlled by relatively steep slopes and generally occurs on hillside cliffs which can trigger an increase in the degree of steepness of the slope.

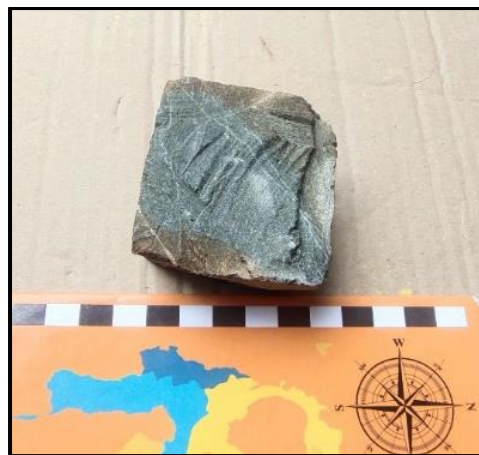
Fig. 5. Appearance of andesite lithology sample at observation station 1

The lithologic features of andesite in the Tinombo Formation in this study area were observed megascopically. Andesite lithology is found at stations 1 to 5 in the Salubomba Village area (Figure 5). The andesite lithology found in the fresh state is gray, in the weathered state is blackish brown with hypocrySTALLINE crystallinity texture, aphanitic-porphyrific granularity, and subhedral shape, in equigranular relation; massive structure, mineral composition of quartz, plagioclase, orthoclase, hornblende, and biotite. Based on the darkness of the rock's color, mineral composition, and rock texture, the rock's name is andesite (Fenton, 1940).

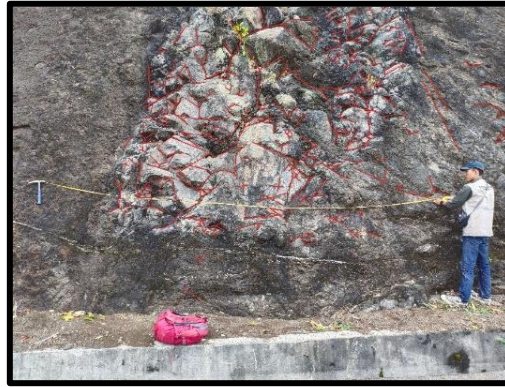
Fig. 6. Appearance of scouring bridle structure on the slope of andesite lithology at observation station 1.

Observations in this study were made in the field in the form of observations of bridging on road slopes. The bruises in the study area are grouped on the basis of their shape and genetics. Through the results of observations and measurements on rock slopes at the research location. Based on their shape, the braces in the study area are included in non-systematic braces. This non-systematic bridle is found in andesite lithology characterized by the presence of bridles that intersect with other bridles with various directions and slopes, these bridles are formed due to compression forces so that the rock becomes eroded. Genetically, the braces in the study area are classified as grinding braces (**Error! Reference source not found.**). The type of bridle, namely the grinding bridle in the study area, is a bridle that can cause rock collapse.

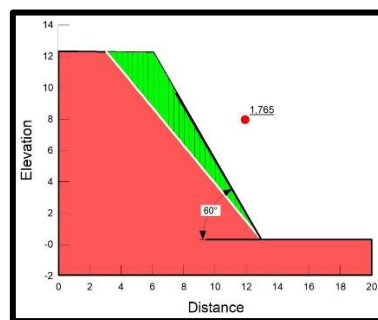
**Fig. 13.** Slope safety factor at observation station 3

Based on data processing in the GEOSTUDIO 2018 R2 software application. Then, the slope safety factor value at observation station 3 is 1.765 (Figure 13). This slope safety factor value is at the low vulnerability level (Landslides rarely occur) based on the landslide hazard classification system according to Ward (1976).

Observation station 3 is located at geographical coordinates  $0^{\circ}45'9.24''$  N and  $119^{\circ}41'5.29''$  E and is located in the middle of the road section of the study area in Salubomba village. The direction of the slope is relatively northeast (dip direction)  $N 230^{\circ} E$  with a slope of  $60^{\circ}$ . The slope at this station has a height of 12.2 meters and a road width of 5.8 meters.
