Surface Rupture Damage Effect on the Active Palu-Koro Fault in Palu City, Indonesia

Abstract

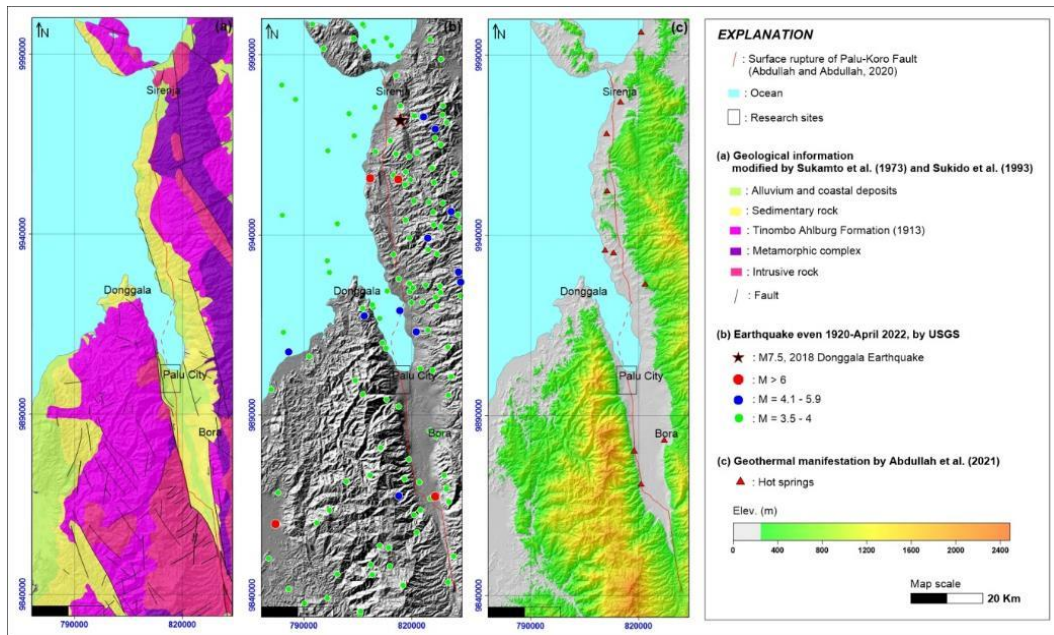
The Palu-Koro fault uniquely correlates with the earth's conditions in the Palu, Sigi, and Donggala areas (see Figure 1). Observations from lithology mapping conducted by Sukanto *et al.* [11] and Sukido *et al.* [12] reveal that the Palu-Koro fault path is prominently situated between the contact of sedimentary rock formations and igneous or metamorphic

Figure 1 Surface rupture path of the Palu-Koro fault on a) Geological map, b) Earthquake epicenter, c) Topography and distribution of geothermal manifestations

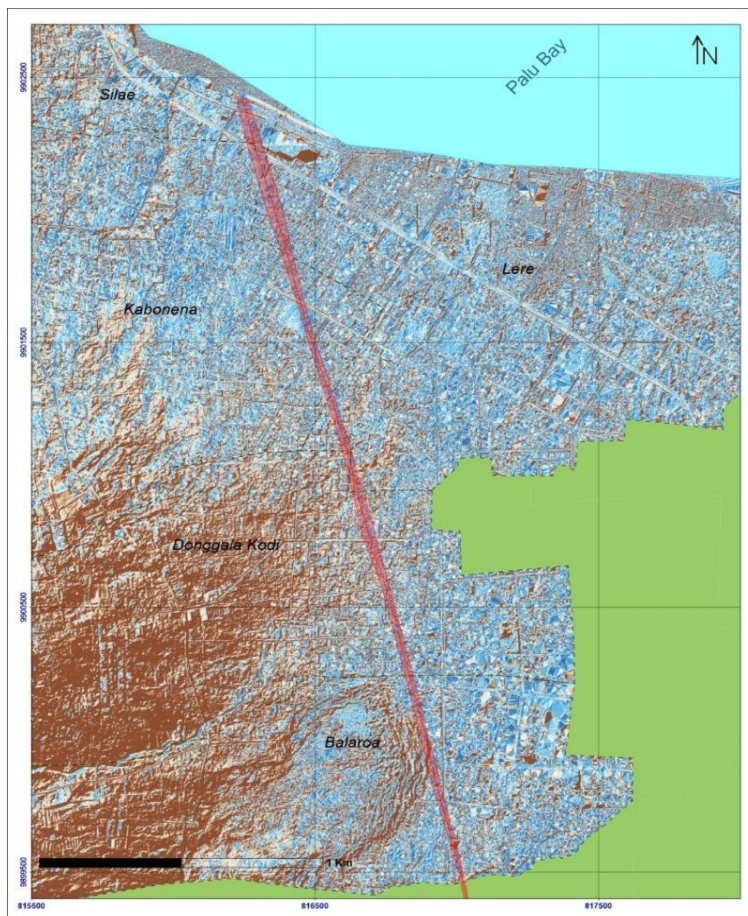
Figure 8 The hazard zone map of active Palu-Koro fault Surface rupture in Silae, Lere, Kabonena, Donggala Kodi, and Balaroa Villages, Palu City

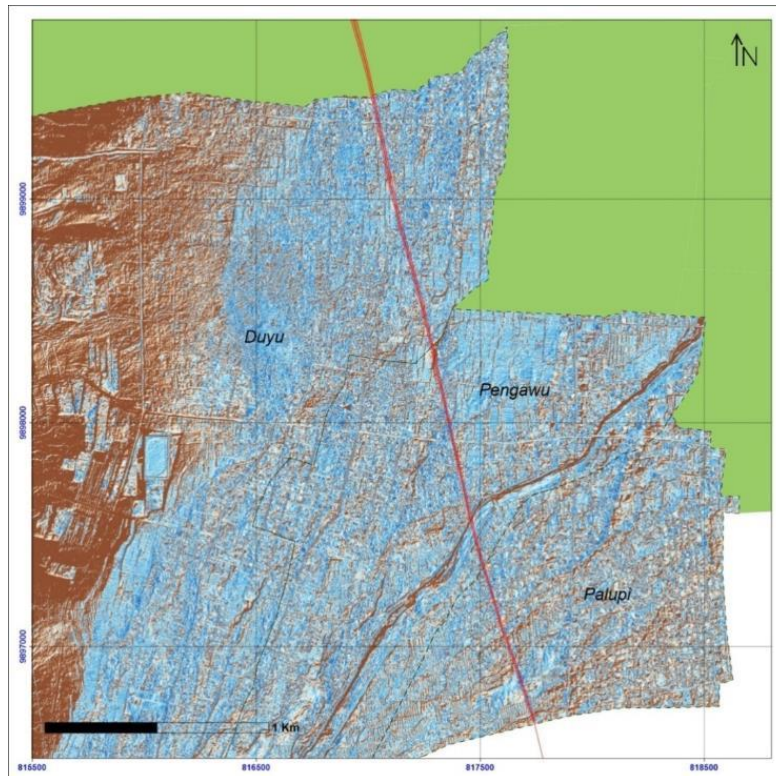
Figure 9 Surface rupture hazard zone of active Palu-Koro fault map in Duyu Village, Pengawu, and Palupi, Palu City
